Driveline Proving the worth of regearing

While replacing a manual with an automatic transmission is no easy task, Driveline still took up the challenge. Now functioning trouble-free for a year and a half, customer satisfaction is proof positive that this concept can get off the ground.

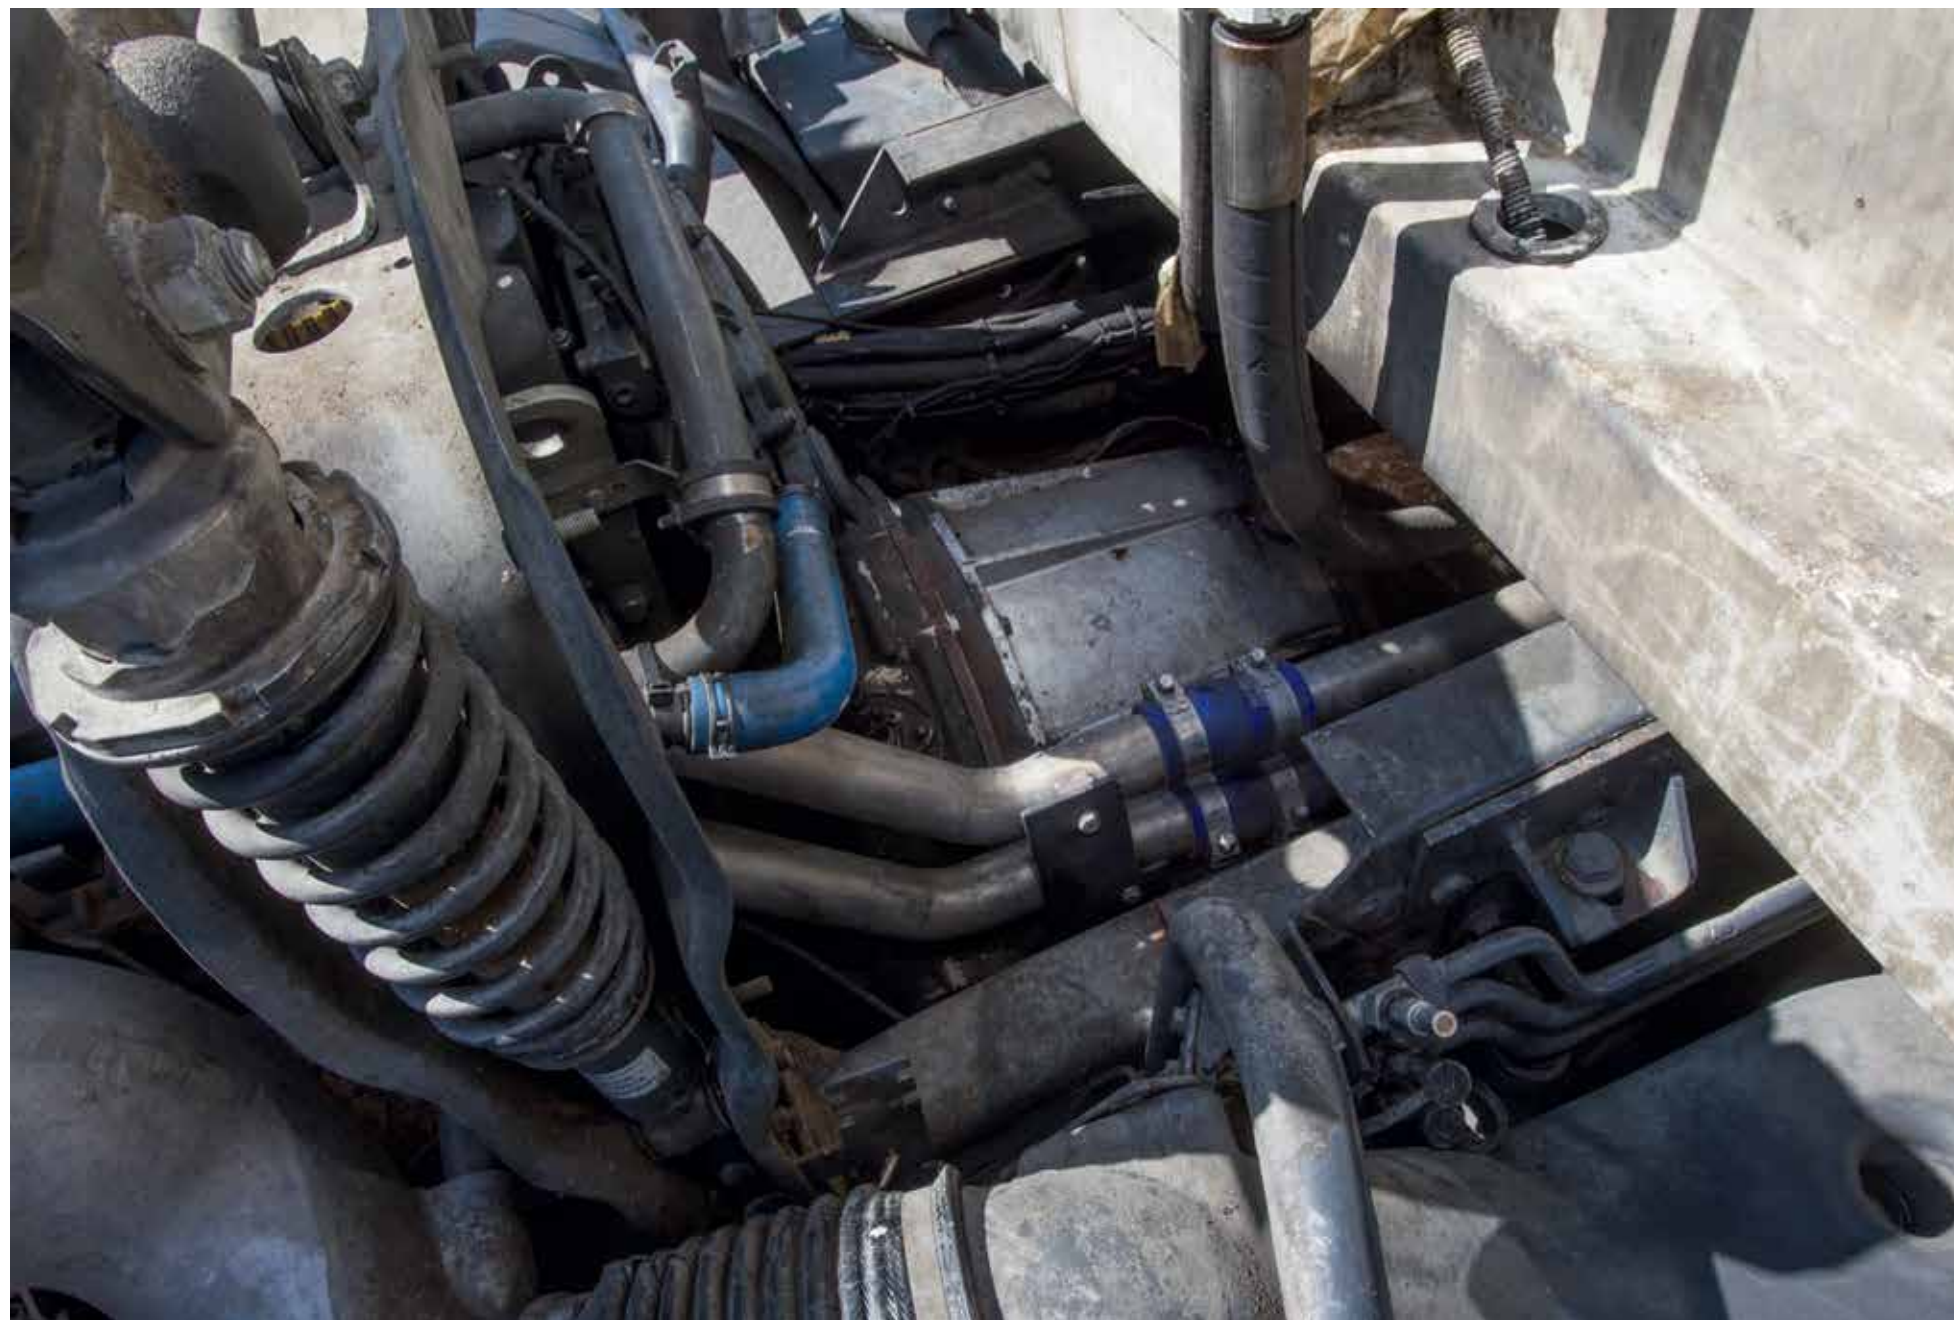
Filipe Cerdeira (Driveline), Francisco Fernandes and Duarte Sanfins (FCC), and Álvaro Vilar Moreira (Driveline), the mentors of this project

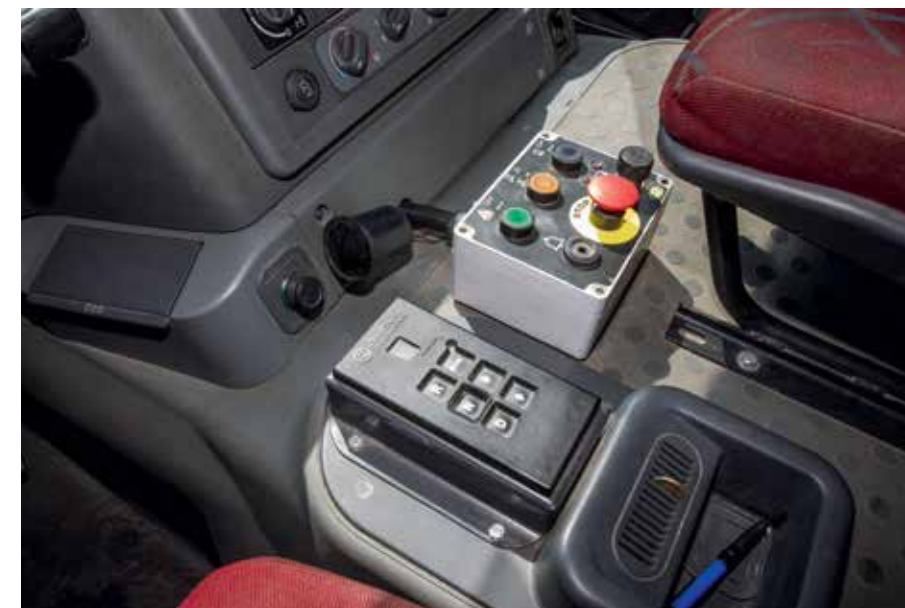
The position of the new gearbox selector was looked into, in order to bring about ergonomics of use

With the new gearbox now in place, we needed to measure the distance between the gearbox outlet flange and the differential outlet, in order to make the new drive shaft, considering the specifications accepted by Allison so that no component is damaged. Finally, we also needed to perform some "cutting and sewing" in the cabin, so as to fill the spaces left empty by the removed components and to ergonomically adapt the new components in

the passenger compartment, such as occurred, in this case, with the gearbox selector.

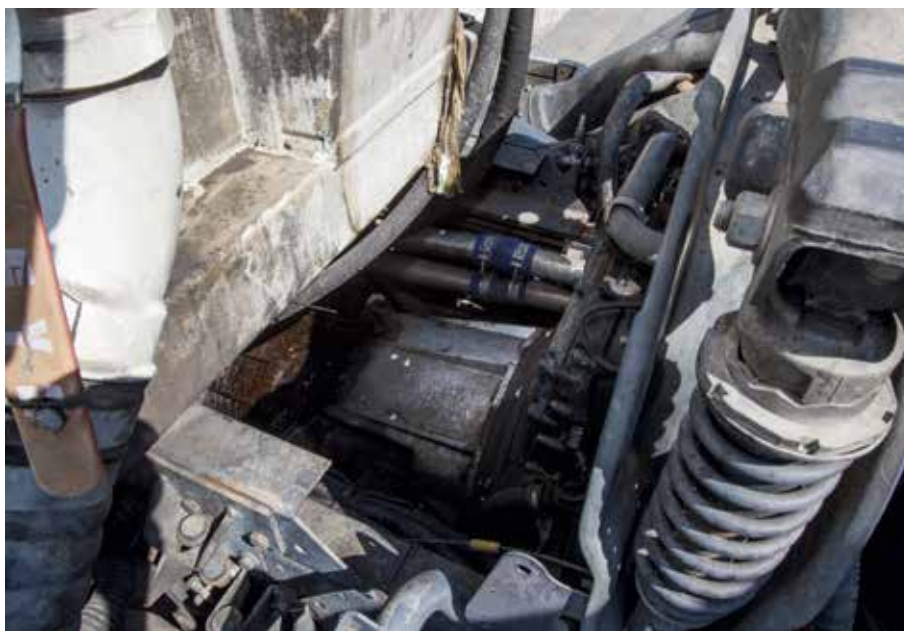
The gearbox cooling system was designed and executed at Driveline's facilities

Afterwards, the new gearbox was connected to the engine and the cooling system was created. The pipes that lead water from the engine to the internal cooler were all designed and mounted by Driveline; the same was true with the wiring connecting the components to the vehicle's CAN line. After these were installed, as well, we needed to find a safe, moisture-free space for the electronic control unit, which ended up being accommodated underneath the vehicle's passenger seat.
